Mandibular Rehabilitation with Conus-Retained Implant Overdenture. A Case Report

Theocharis Nikellis DMD, H. Kavoukdjian DDS, E. D'Silva DDS MS, G. Carranza DDS, Carlo Ercoli DDS

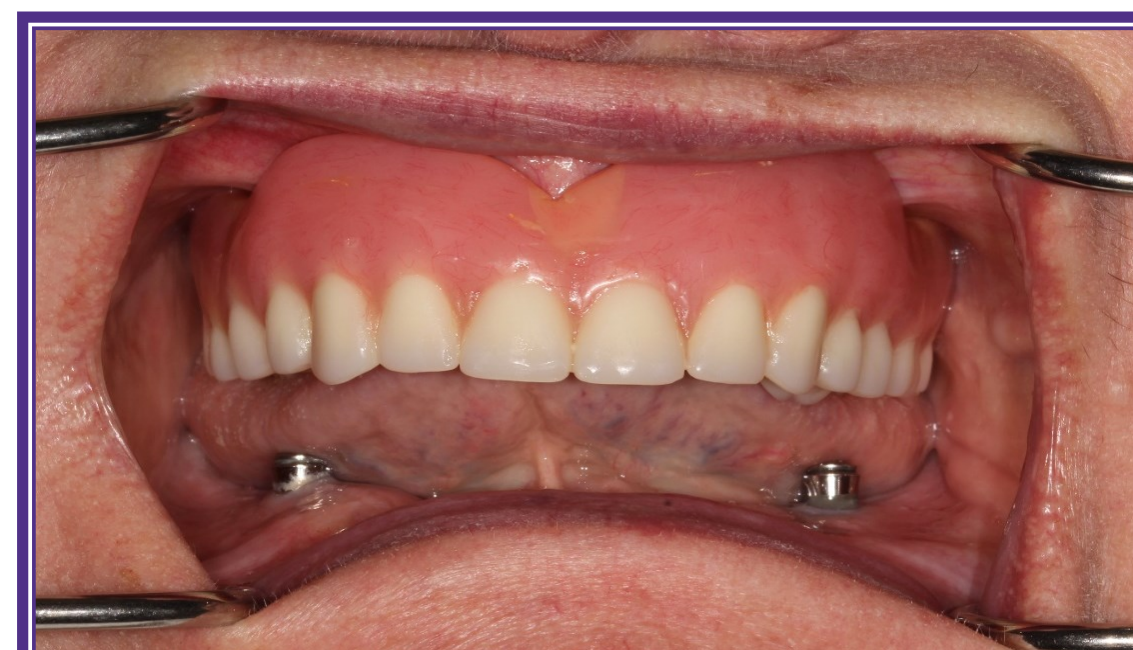
The patient presented to the Department of Prosthodontics with five mandibular implants, three of which were diagnosed with peri-implantitis.

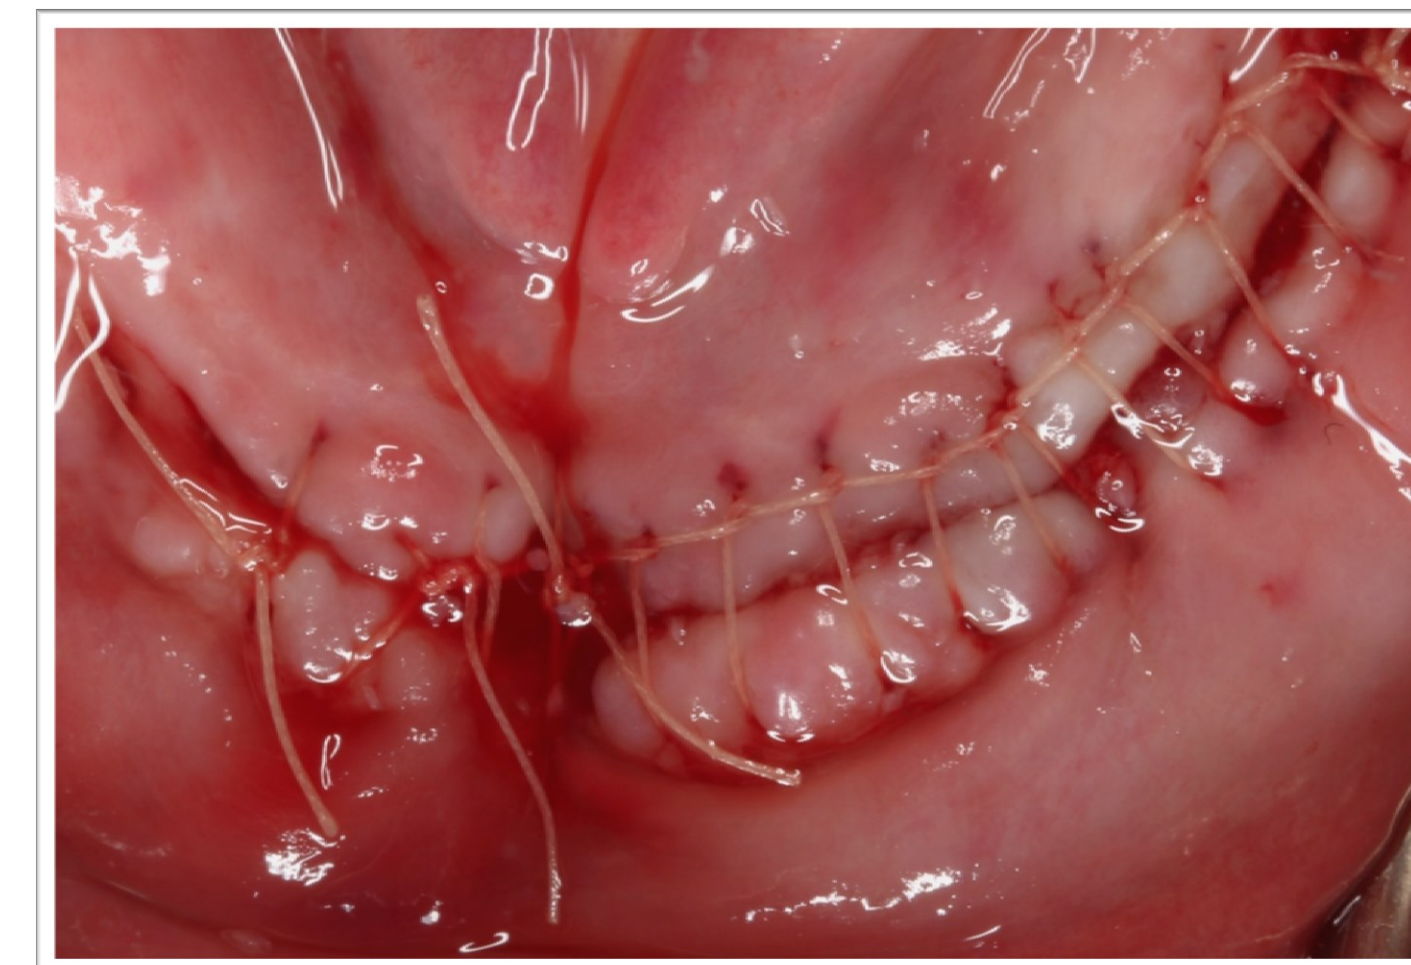
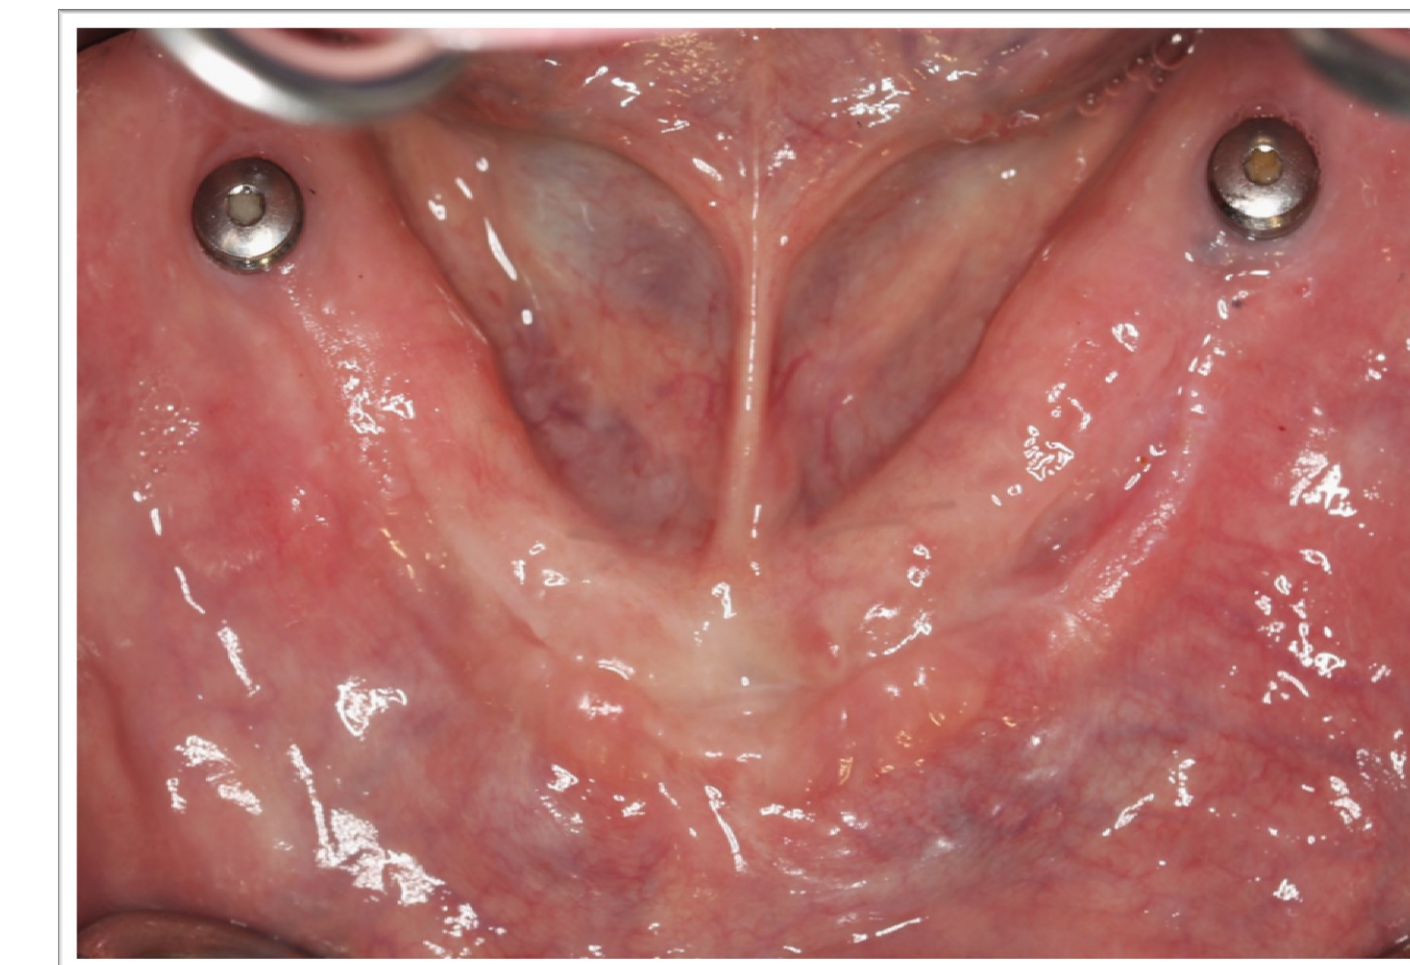
Explantation & bone grafting

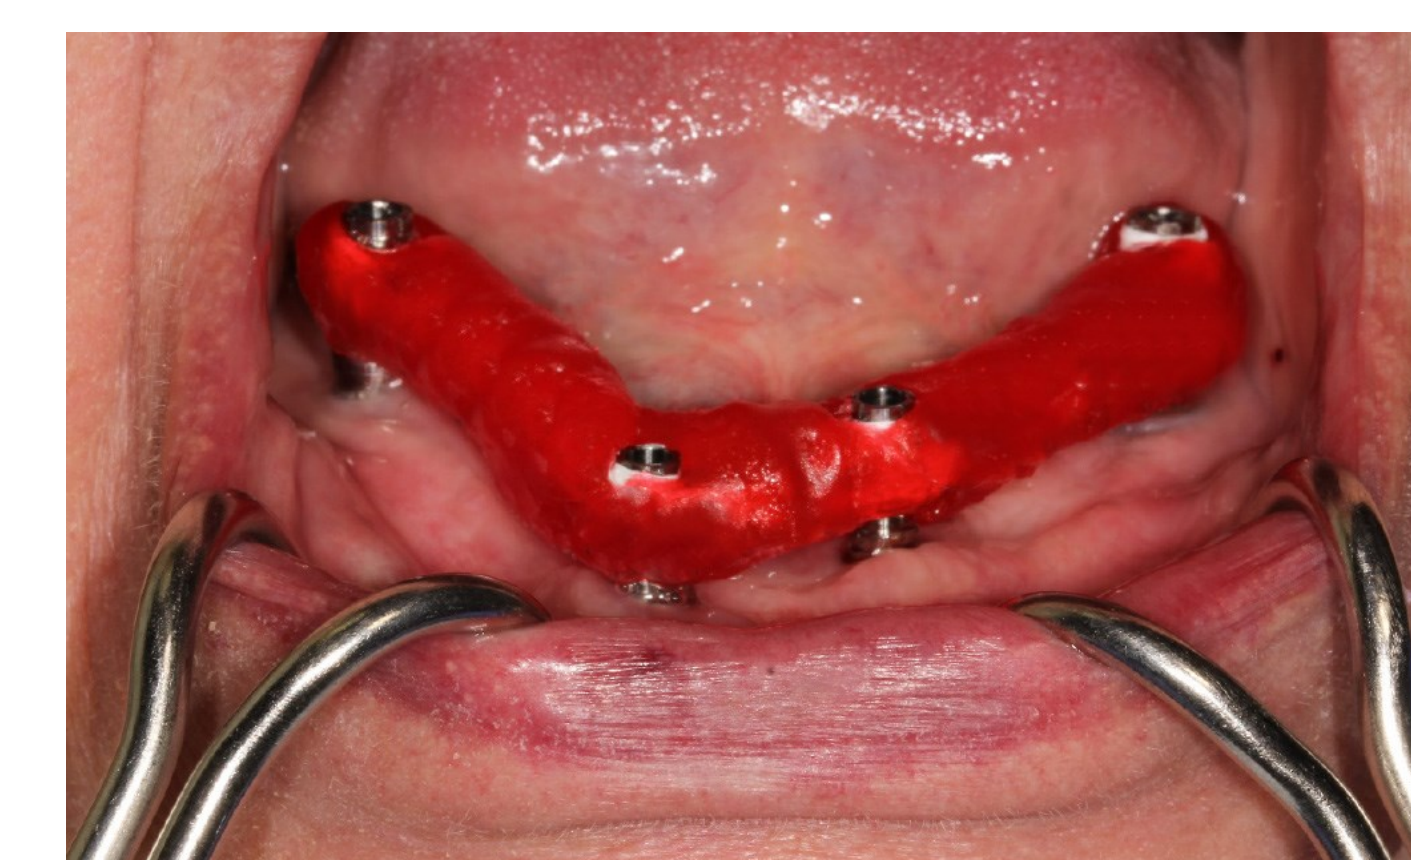
Prosthetic Treatment
